Kalıcı Organik Kirleticiler (KOK) ile Kirlenmiş Sahaların Tespiti ve iyileştirilmesi Projesi

International Best Practices: Case Study on PCB Contaminated Site

26 Ocak 2023

INCEL, Banja Luka, PCBs Detailed site assessment and Risk assessment of the PCB contaminated areas

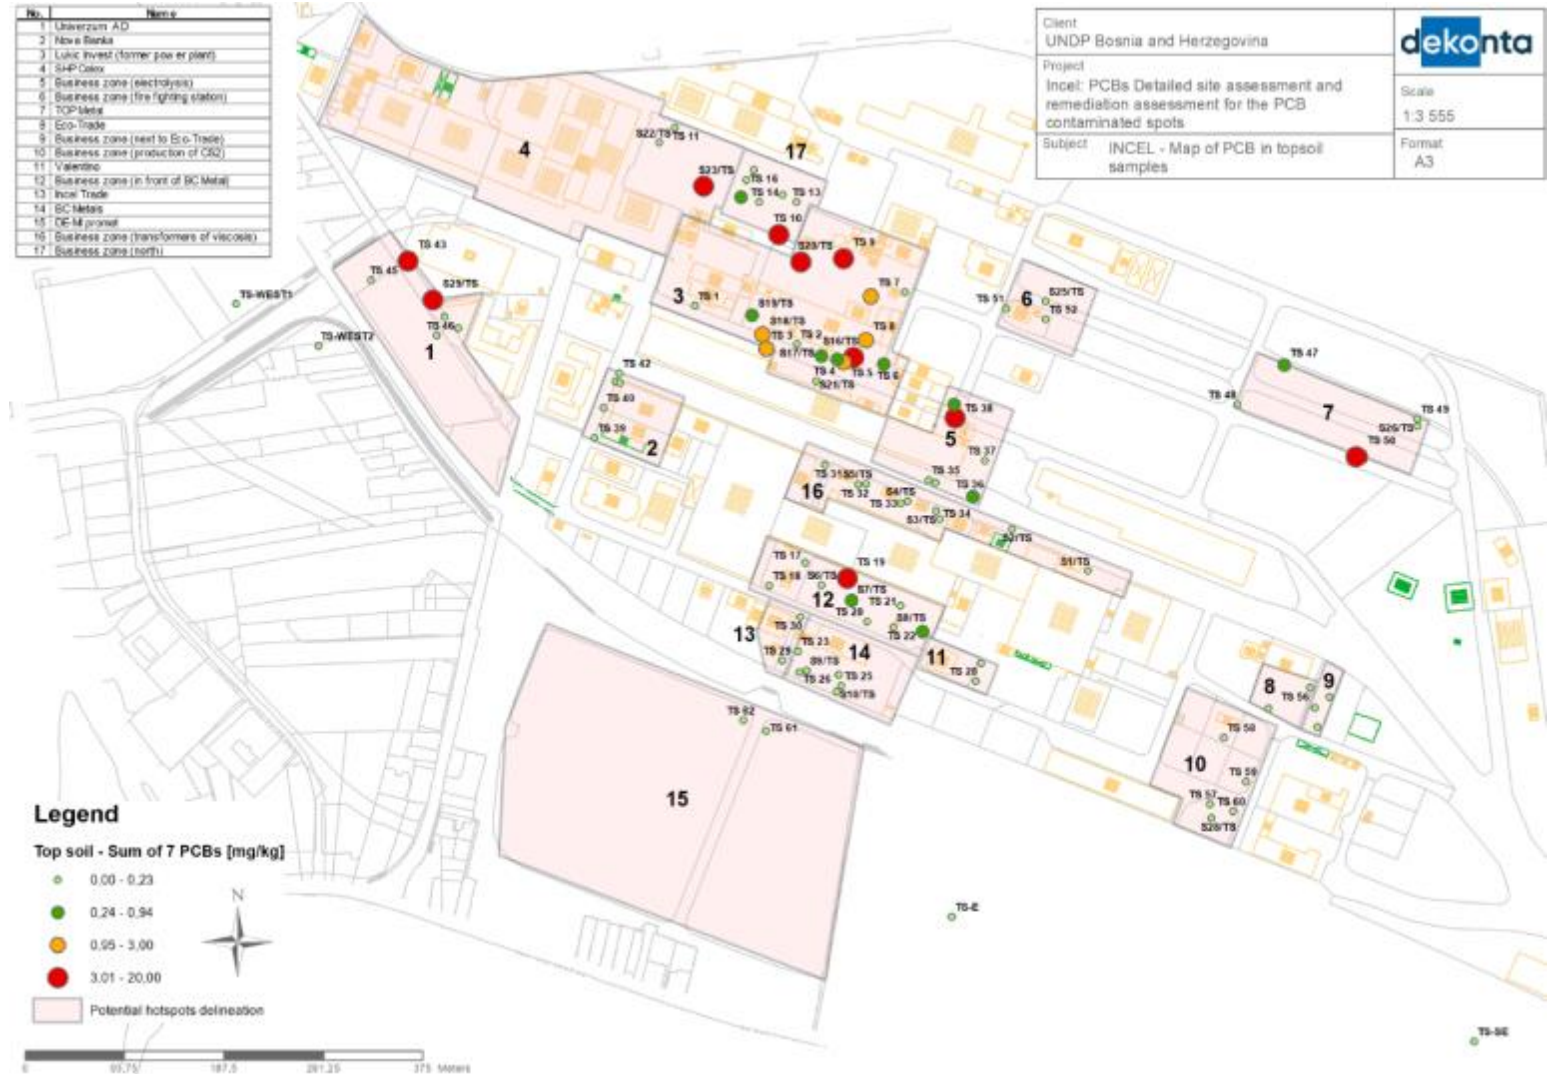
Main 2020 results - PCBs:
Topsoil: 15 samples out of 91 over limit 0,94 mg/kg of dry matter

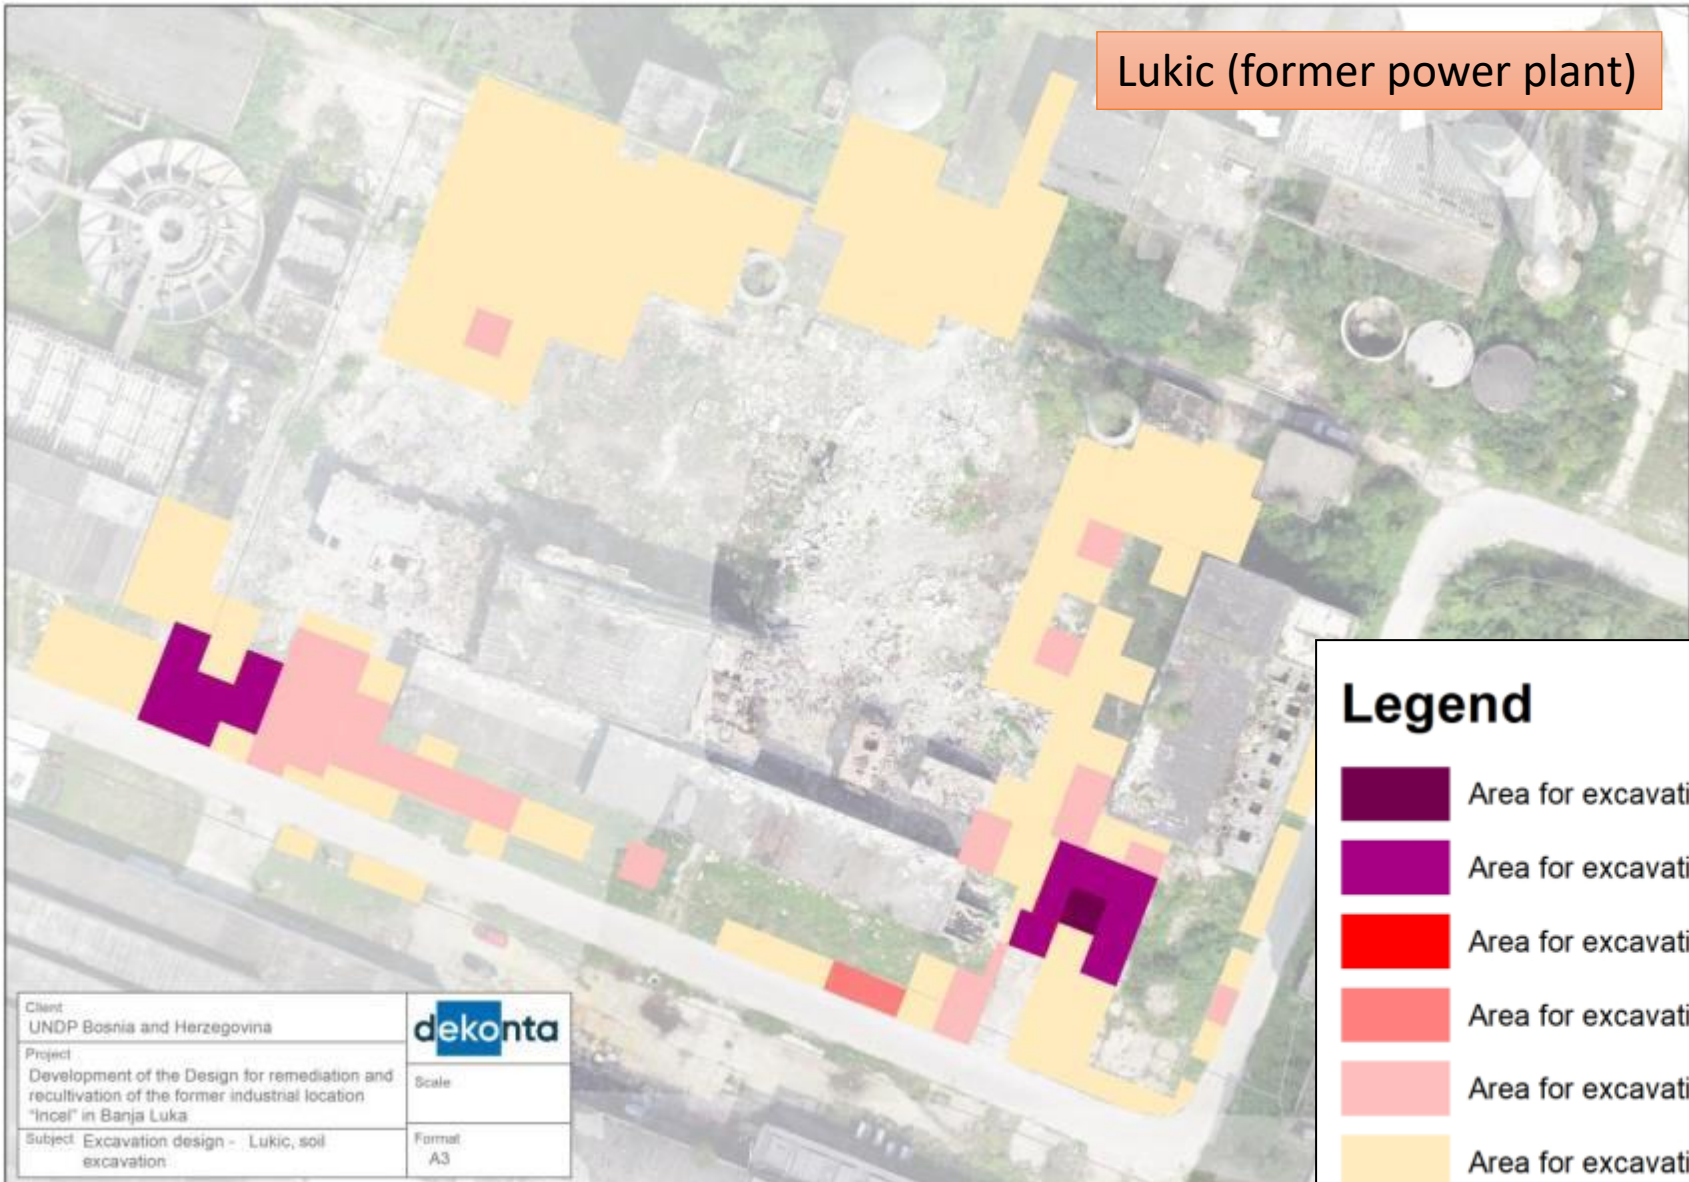
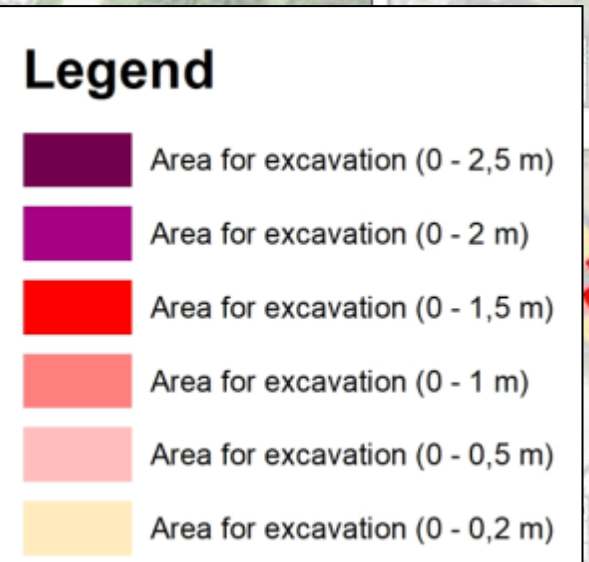
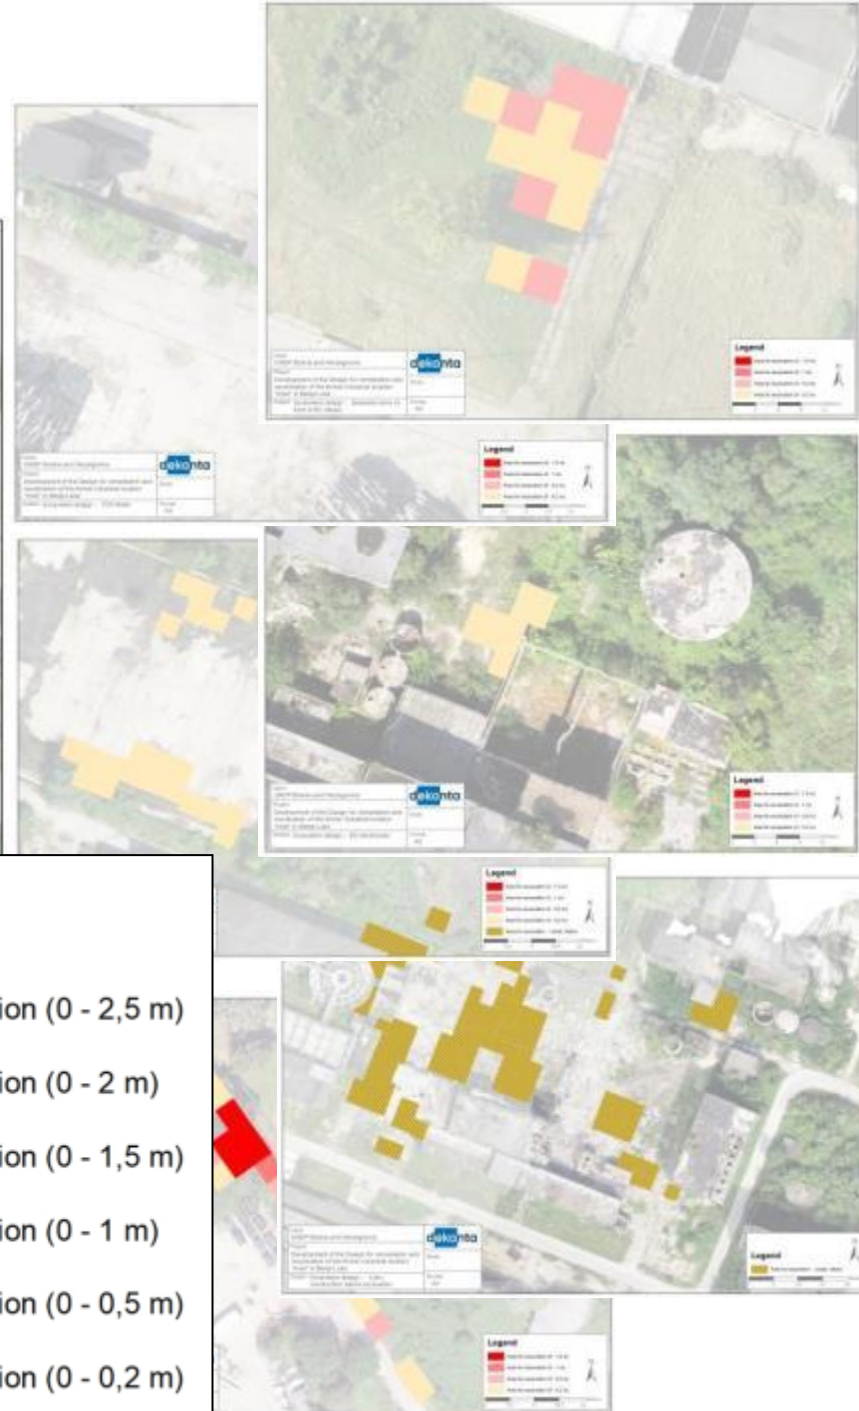
Lukic (former power plant)

Client UNDP Bosnia and Herzegovina	
Project Development of the Design for remediation and recultivation of the former industrial location "Incal" in Banja Luka	Scale
Subject Excavation design - Lukic, soil excavation	Format A3
