POPs stockpile Merkim site, Kocaeli, Turkey

**Detailed site survey/assessment, operational planning,
environment/safeguards assessment, training and
supporting technical supervision related to the removal of
POPs**

Task 2: Site Description Survey and Assessment Report

23 January 2017

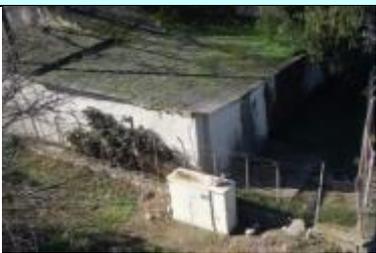
Ware-house	Width (m)	Length (m)	Height (m)*	Area (m ²)	Description	Picture
1	10	16.5	3.5**	165	Northern most warehouse. It has a flat roof of asbestos, on metal rafters. Walls are cement blocks with part of the Northeast wall missing and replaced by corrugated iron sheets. Warehouse 1 has concrete floors. Entrance to the warehouse through demolished wall with warehouse 2

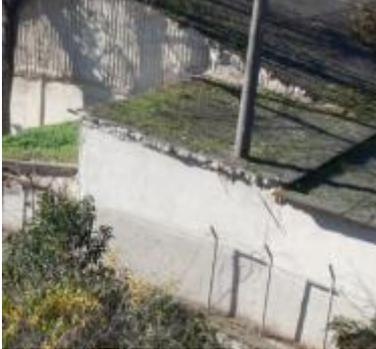
Ware- house	Width (m)	Length (m)	Height (m) [*]	Area (m ²)	Description	Picture
1b	6.3	5.2	4.6**	32.8	Small building next to warehouse 1. It has a slanted roof of asbestos. Walls are cement blocks. In the middle of the building is a pit of 3.6 x 2.6 m and 1 m deep. The pit is partially filled with construction wastes and partially with POP pesticides. A disused phone or electricity pole is present in the corner.

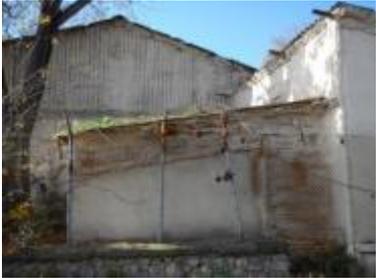
1c	6.3	5.2	3.5***	32.8	Small building that is empty and completely closed. It is not accessible through any door as the building has been sealed. It has a flat roof of asbestos, on metal rafters. There is a small closed corner which presumably has no roof as light comes in.

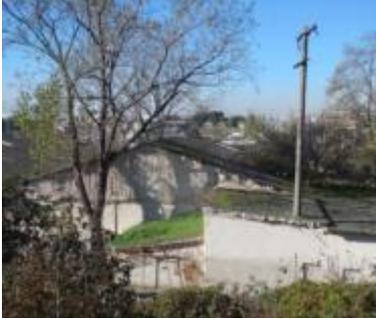
2	20	20	8.1	400	Second warehouse from the North, configuration of warehouse is similar to warehouses 3 - 6 but size is somewhat smaller. It has a slanted roof made of asbestos, on metal rafters. Walls are cement blocks with reinforced concrete frame. A groundwater extraction well is present in the centre of the warehouse (see figure 2.1). The well is poorly covered and has a diameter of 80 cm and a depth of minimum 11.5 m. A small pit, probably the old pump basin, is present next to the well. The pit is filled with POP pesticides.

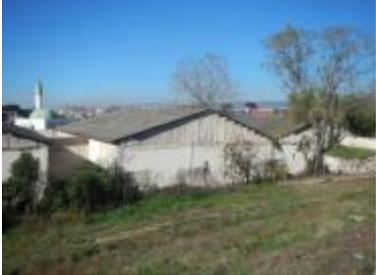
Ware- house	Width (m)	Length (m)	Height (m) [*]	Area (m ²)	Description	Picture
3	20	30	Side 5.5 Ridge 8.5	600	<p>Second most Northern warehouse. This is the only warehouse with access to the outside through a 4 x 4 m metal sliding door with an normal door persons to enter. Warehouse is completely sealed and no daylight enters. It has a slanted roof made of asbestos, on metal rafters. Walls are cement blocks with reinforced concrete frame. Warehouse has concrete floor made of slabs. Between warehouse 3 and 4 is a narrow corridor made of asbestos sheets and corrugated iron roof. This corridor has been built on a concrete floor but has been heightened with soil contaminated with pure pesticides and asbestos as the floor is some 10-15 cm lower than in warehouse 3 and 4.</p>

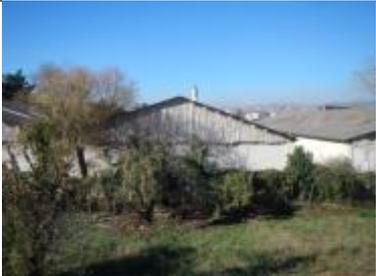
4	20	30	Side 5.5 Ridge 8.5	600	<p>Third most Southern warehouse. It has a slanted roof made of asbestos on metal rafters. Walls are cement blocks with reinforced concrete frame. Warehouse has concrete floors in generally good condition. It has one sealed 4 x 4 m metal door on the west side.</p>

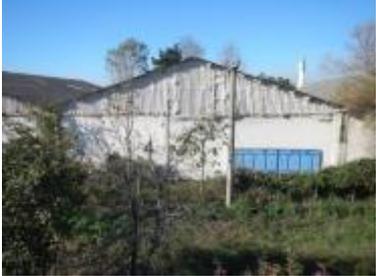
5	20	30	Side 5.5 Ridge 8.5	600	<p>Second most Southern warehouse. Has similar configuration as warehouse 4.</p>

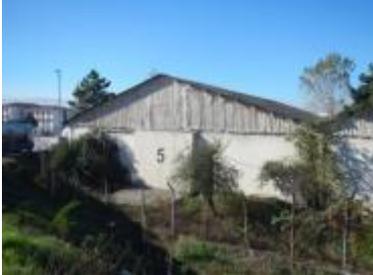
Ware- house	Width (m)	Length (m)	Height (m)*	Area (m ²)	Description	Picture
6	20	30	Side 5.5 Ridge 8.5	600	Most Southern warehouse. Has similar configuration as warehouse 4. Warehouse has a 4 x 4 m metal access doors on the East side

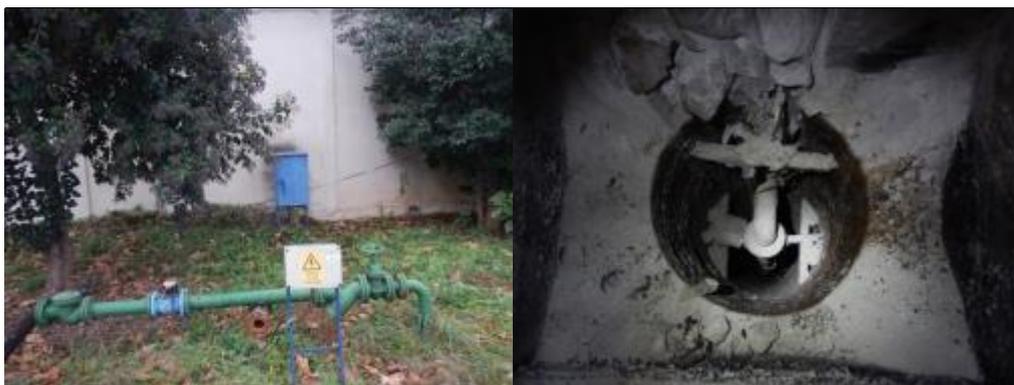
Three active groundwater extraction wells are present at the site. One well is located just North of the site entrance (see figure 2.1), the second well is at the entrance to the decontamination unit area (between warehouse 3 and 4) and the third well is in the Southern end of the site. The wells are closed circuit wells made of steel. Extracted water is used for processing at the Koruma Klor Alkali San. ve Tic. A.Ş chemical factory. Inside warehouse 2 a non-operational old groundwater extraction well is also present.

Figure 2.1 Water extraction well (left) and indoor well in warehouse 2 (right)

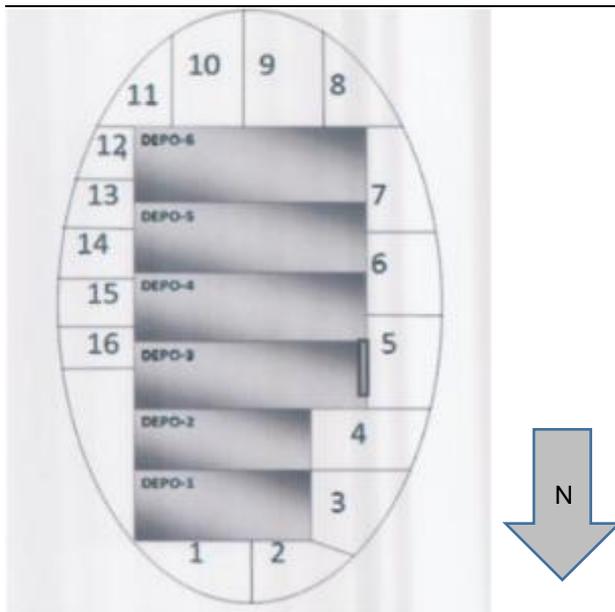
The MAM Tübitak investigated the soil within the compound premises by dividing the outdoor areas in 16 separate areas where composite samples were taken as illustrated in figure 4.1. Table 4.3 gives for each soil sample the soil sample number the location (as in figure 4.1) and the analytical results parts per million (ppm).

Figure 4.1 Location of soil samples – MAM Tübitak report 2013 (North is to the bottom of the picture)

The MAM Tübitak results of the soil samples show that the main soil contamination to be present around the current entrance to the site, the North part of the site and on the eastern side of warehouse 4. Since no entrance is present on the Eastern part of warehouse 4, the most likely cause of the high concentrations of pesticides in the soil there is cross-contamination during the sampling. An unknown source area for POP-pesticides (for instance due to a gap in the wall that caused airborne particulate) and/or seeping rainwater from the warehouse floor can however not be excluded.

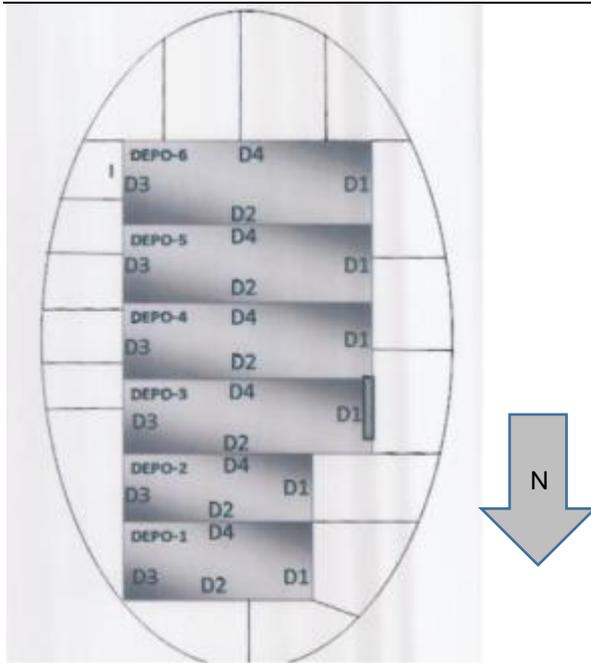
MAM Tübitak also sampled the floors and walls inside the warehouses as indicated in figure 4.2. Sampling was done by collecting dust from the walls and floors. The dust samples were analysed for HCH, DDT and their isomers. The analytical results of the wall and floor samples (ppm) are given in table 4.4.

Figure 4.2 Sample location of wall and floor samples – MAM Tübitak report 2013 (North is to the bottom of the picture)

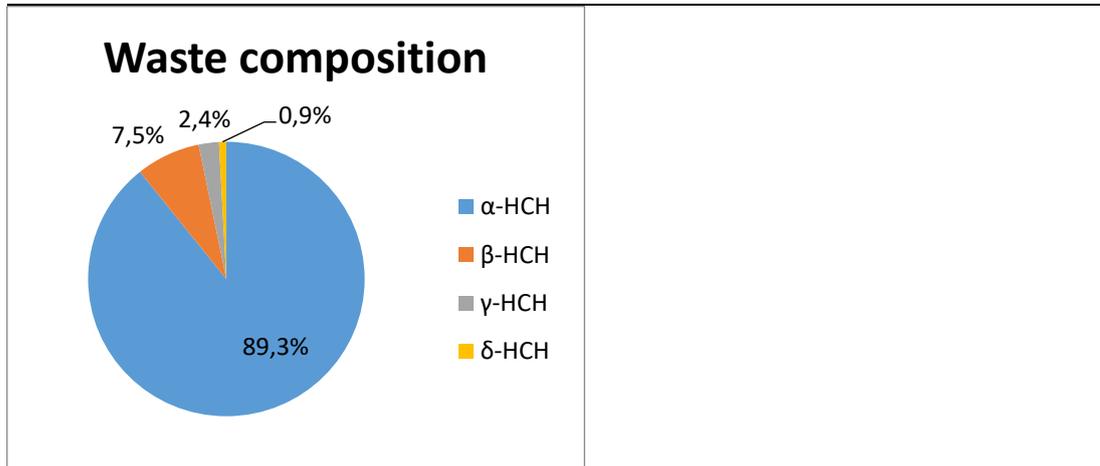
The MAM Tübitak waste sampling shows that the wastes found at the site contain 29-41 % HCH isomers, with the rest inorganic material. Out of the total weight, 26-37 % was found to be α -HCH, and 0.05-1.3 % γ -HCH. This is consistent with Lindane-productions wastes. The below diagram (figure 4.3) shows average POP waste composition based on the MAM Tübitak results.

Figure 4.3 HCH composition in waste pile samples of MAM Tübitak

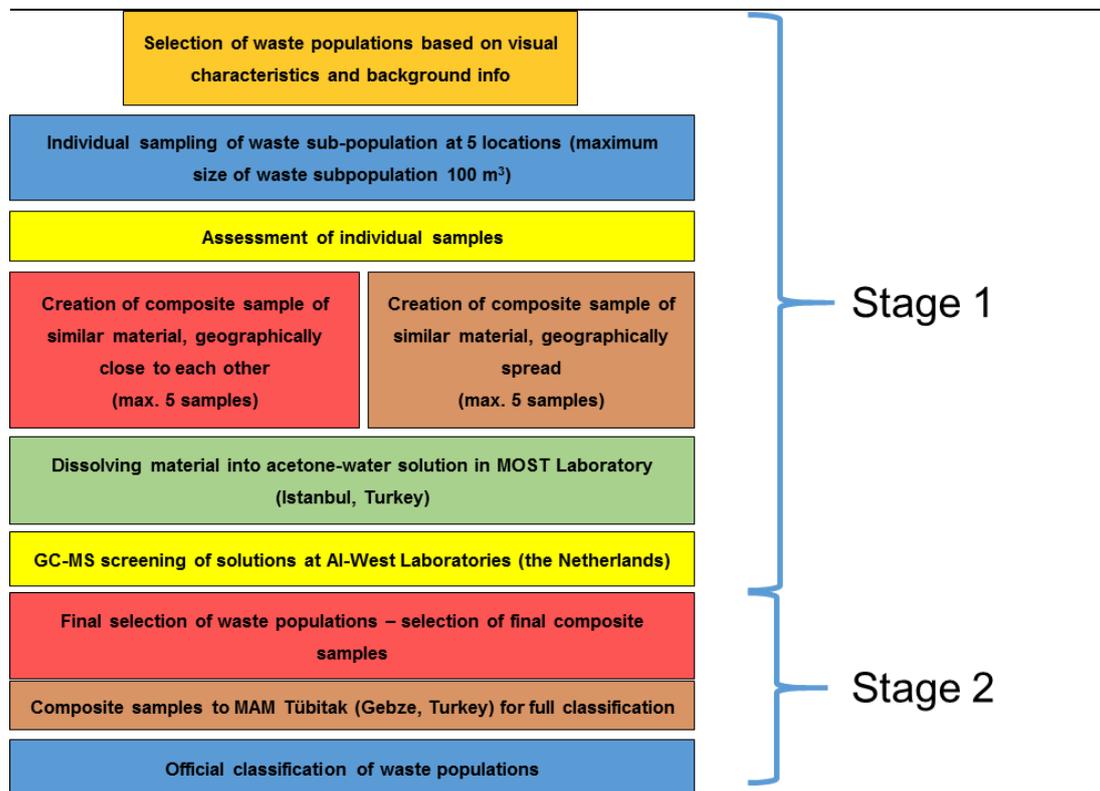
The composite samples were transferred to MOST Laboratories in Istanbul to dissolve the sample materials in an acetone-water solution. The protocol for the MOST Laboratories is given in Section 4.2.5 of the Inception Report (Tauw Reference R002-1239389GMC-los-V02-NL). Dissolved samples were shipped to AL-West laboratories in the Netherlands for GC-MS screening for non-volatile components.

Figure 5.1 Sampling procedure POP-pesticides bags in two stages

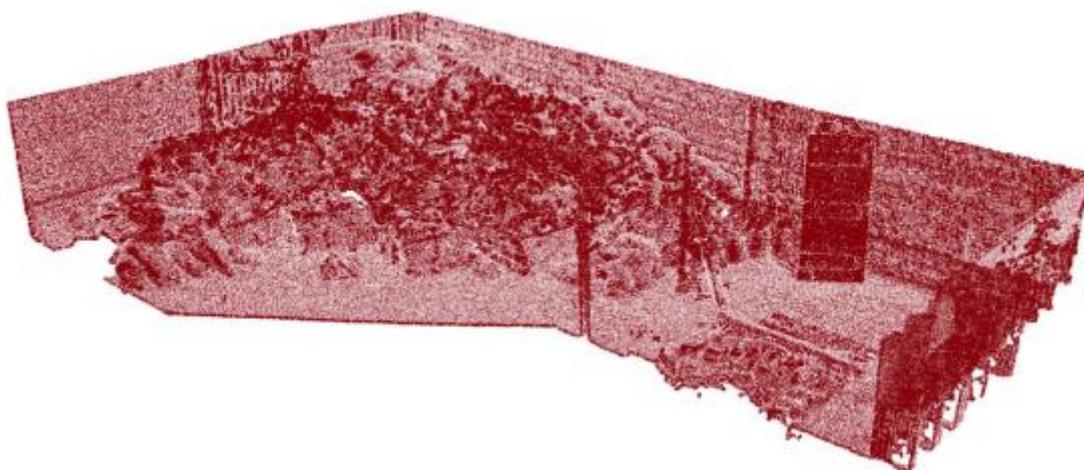
To assess the total quantity of bags with POP-pesticides present in the warehouses 1, 4, 5 and 6 a 3D map of the warehouse interior using a laser scanner (Faro 330 3D Lazer) with two base station (Sokkia 530RK) was made. Laser scanning was executed by EMA Harita survey company under supervision of Tauw.

The laser scanner made a 3D map of the warehouses with an accuracy of 2 cm.

Figure 5.2 3D scan of wastes in warehouse 1

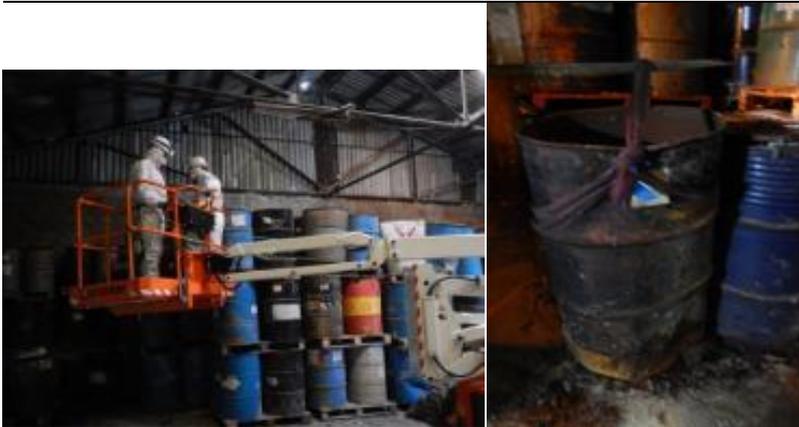
Drums in very poor state have been manually repacked in empty drums in better condition present at the site. These severely damaged drums have been added to scrap metal pile on site. Drums are in such a poor condition that none of them is suitable for re-use or future transport.

Where necessary, pallets have been replaced to allow for more appropriate stacking. For the movement of the drums a Komatsu electric forklift with built-in scale was used. The Komatsu forklift scale was used to assess the weight of the drums. Accuracy of the scale is estimated at $\pm 20\%$.

Figure 5.3 Banding of drums (left). Individual weighing and transport of drums (right)

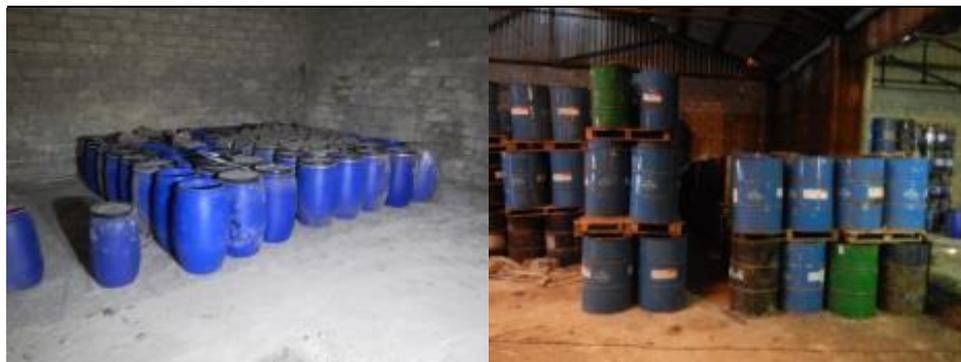
Empty drums have been collected by type and counted (see figure 5.4). For the empty drums their specific weight has been recorded to allow for calculation of total weight.

Figure 5.4 Empte PP drums (left). Empty steel drums (right)

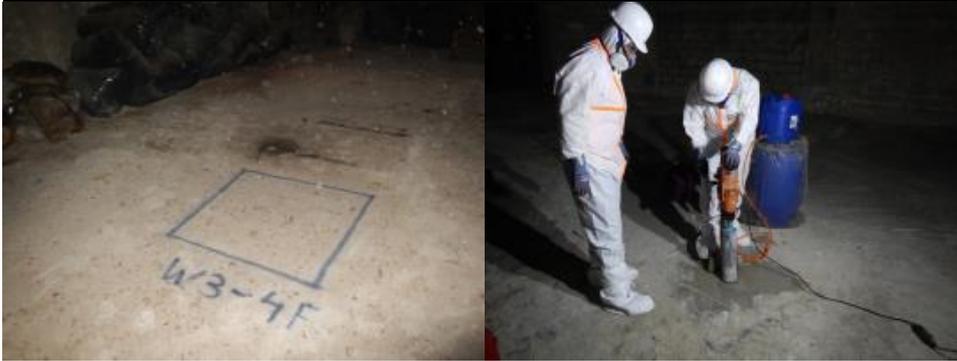
- At 8 locations spread out over warehouses 1 – 5 a representative m² square was spray painted on the floor (see figure 5.5). All loose material within the m² was collected and weighed to provide an impression of the total quantity of material present
- Cracks in the floor have been cleaned and their depth checked at indicative locations
- At three locations a concrete core was taken from the floor
- At two locations the concrete floor support layer beneath the floor was assessed by manually drilling till the original soil

After concrete coring, at two locations, using an Edelman hand auger the support layer for the concrete floor was checked. Manual drills were made through the support layer till maximum 1.2 m below the floor surface. Three samples were taken and analysed for DDT and HCH, one sample was taken and analysed for Polycyclic Aromatic hydrocarbons (PAH), Total Petroleum Hydrocarbons (TPH, C10-C40) and Heavy Metals (Cu, Pb, Zn, Cd, Cr, Ni, As, Co, Hg) at MOST Laboratories in Istanbul. Holes left after concrete coring have been filled with cement.

Figure 5.5 Weight of materials on the floors (left) Concrete coring (right)

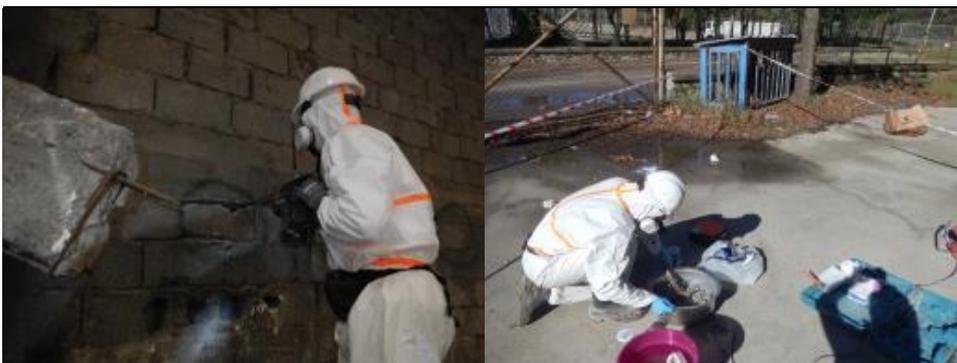
Figure 5.6 Collection of building blocks (left) Outside processing of blocks prior to transfer to laboratory (right)

Holes in the walls have been closed with new lightweight building blocks and polyurethane foam for airtightness.

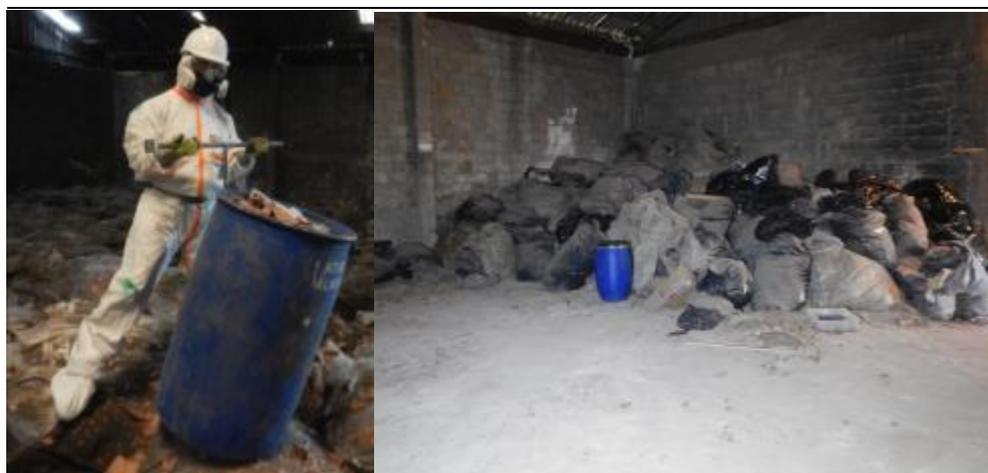
During the fieldwork it became clear that large quantities of packaging wastes were present in warehouses 4 and 5. To get an indicative impression of the specific weight of this material the material was collected in 200L drums at three separate locations (see figure 5.7). For locations where the wastes were more compacted 40 % more material was collected to compensate for the loosening of the materials during the transfer to the drum for weighing. The PPE wastes next to the entrance (see figure 5.7) were assessed by weighing individual bags.

Figure 5.7 Weighing of packaging wastes (left) PPE wastes next to entrance (right)

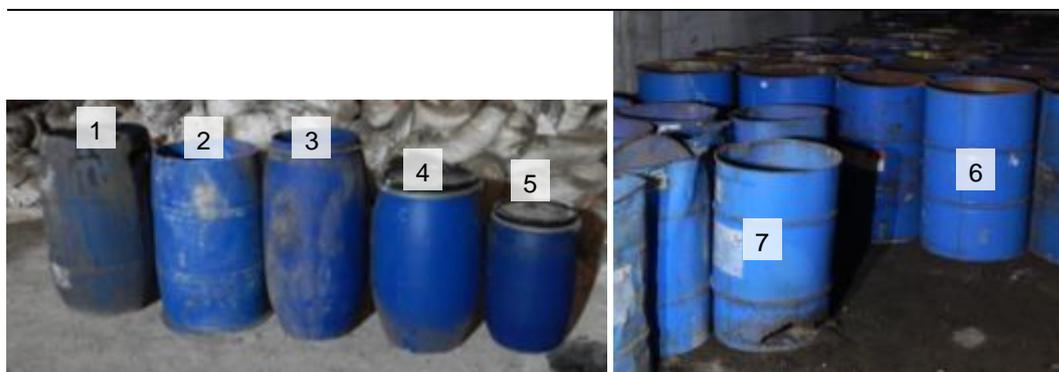
Drum	Drum size	Weight (kg)	Number in figure 6.1
Empty open head steel drum of 200 litres with no cover	200 L	13.2	6
Empty light blue open head steel drum of 125 litres	125 L	8.6	7
Steel drum cover for open head steel drum of 200 litres	n.a.	2.6	n.a.

Figure 6.1 Drums types present at the site

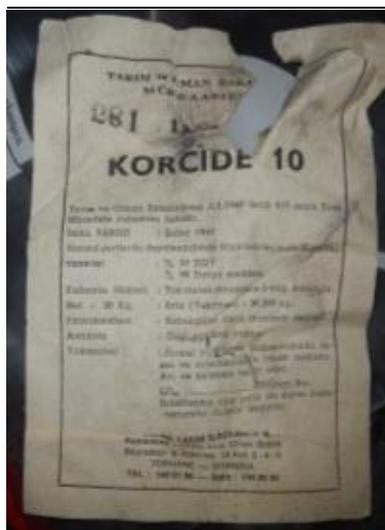
Labels found inside DDT containing bags (see figure 7.1) show that the specific weight of DDT containing bags is 1,006 kg/m³. For calculation purposes the following specific weights will be used.

The indicative analytical results prove that all wastes are POP-pesticides. In most cases wastes are HCH waste products with a purity of approximately 40 % (i.e. 40 % of the material is POP-pesticides, 60 % is inorganic mixture). Limited quantities of Technical HCH (samples W4-2 D1, WT1 D1 and WT2 D1) and DDT end products (samples W1-1 D1 and W6-4 D1) have been found. The DDT end product is likely called 'Korcide 10' as labels of this material have been found inside some of the bags (see figure 7.1).

Figure 7.1 Labels found on DDT bags

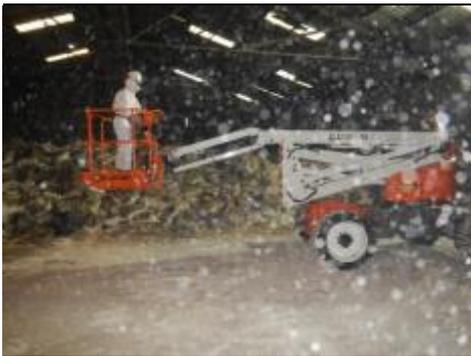
The following paragraphs contain the results of the wall, floor and subsurface sampling at the site. As a cautionary remark it is emphasized that, due to the high concentrations of pesticide dust inside the warehouse (see figure 7.2) and despite our precautionary measures and caution during the sampling, all samples have been impacted by pesticide dust to a certain degree. In addition cross-contamination due to contaminated laboratory equipment cannot be excluded either.

Figure 7.2 Pesticide dust reflecting on the camera flash

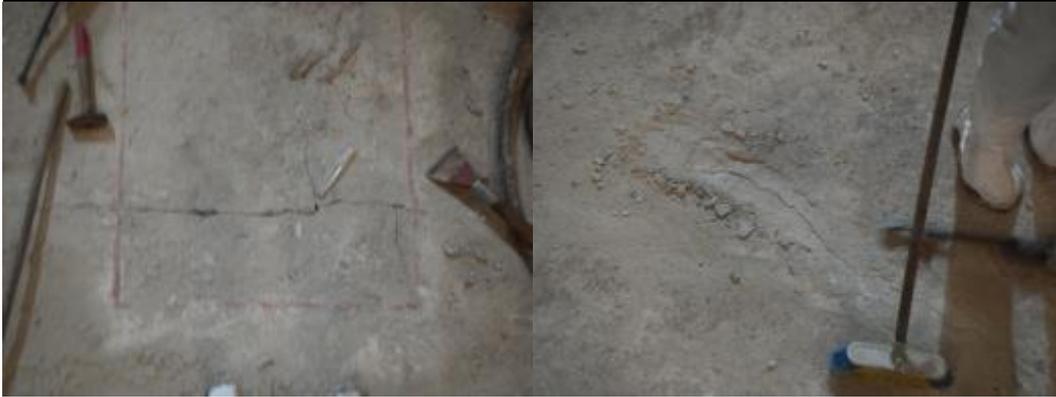
- No clear decrease in POP-pesticides concentrations in concrete core from Warehouse 5
- Prolonged exposure to large quantities of dust
- Prolonged exposure to water
- Large cracks present in the concrete floors (see figure 8.1)

Figure 8.1 Large cracks in site floors (warehouse 4)

For all warehouses the exact penetration depth can only be established by layered removal of the warehouse floors during the execution of the building demolition. Quantities given in table 8.8 are for budgeting and design purposes only.

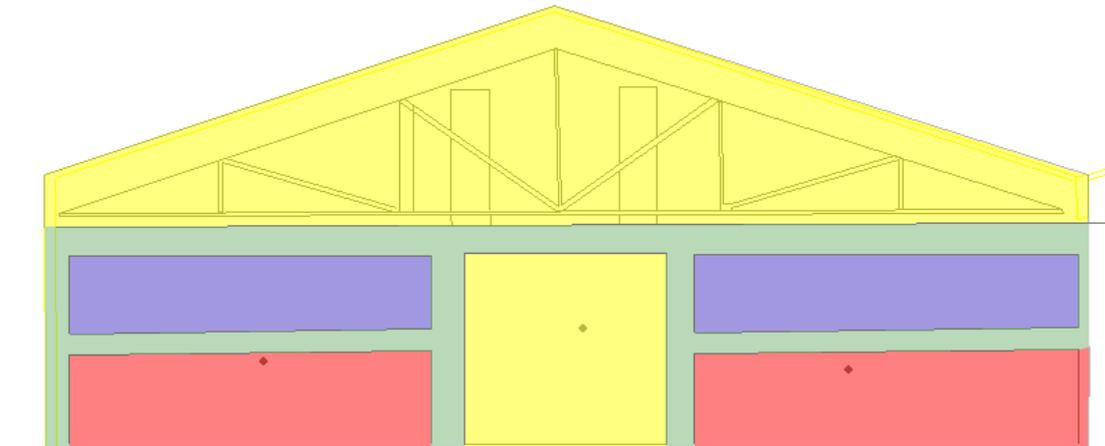
- The first block (bottom – first layer) – not included in figure 8.2
- Contaminated blocks till the first reinforced concrete cross-beams (second layer – red in figure 8.2)

Figure 8.2 Schematic cross-section of building

The bottom or first layers of building blocks have been in contact with POP-pesticides during prolonged periods. Evidence of partial flooding of the warehouse is visible on these blocks especially in Warehouse 4 and 5. We therefore assume that these blocks have the highest POP-pesticides concentrations. Table 8.10 provides an overview of the quantities of these blocks present. Warehouse 1 is omitted from this list as no indication of serious flooding of this warehouse was present.

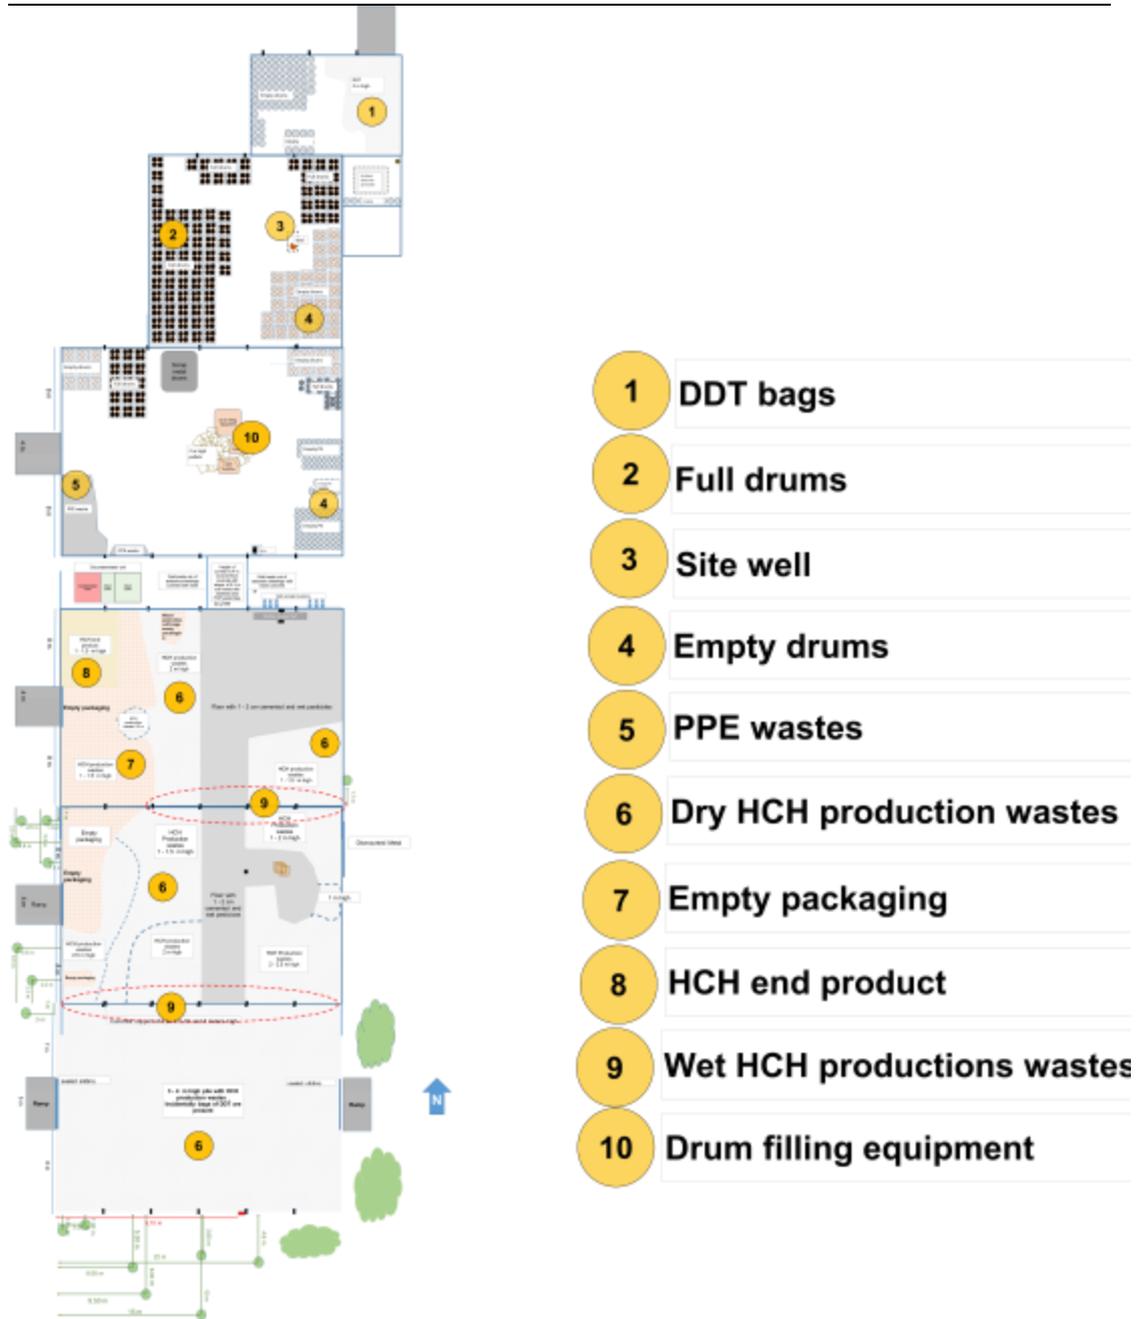
The Conceptual Site Model shows a top view of the warehouse with schematically the presence of bags of pesticides and drums. A cross-section through one of the warehouses is used to provide insight into the overall questions of the area. Appendix 10 shows the conceptual site model in greater detail.

Figure 9.1 The site location sketch illustrating the Conceptual Site Model of the warehouse

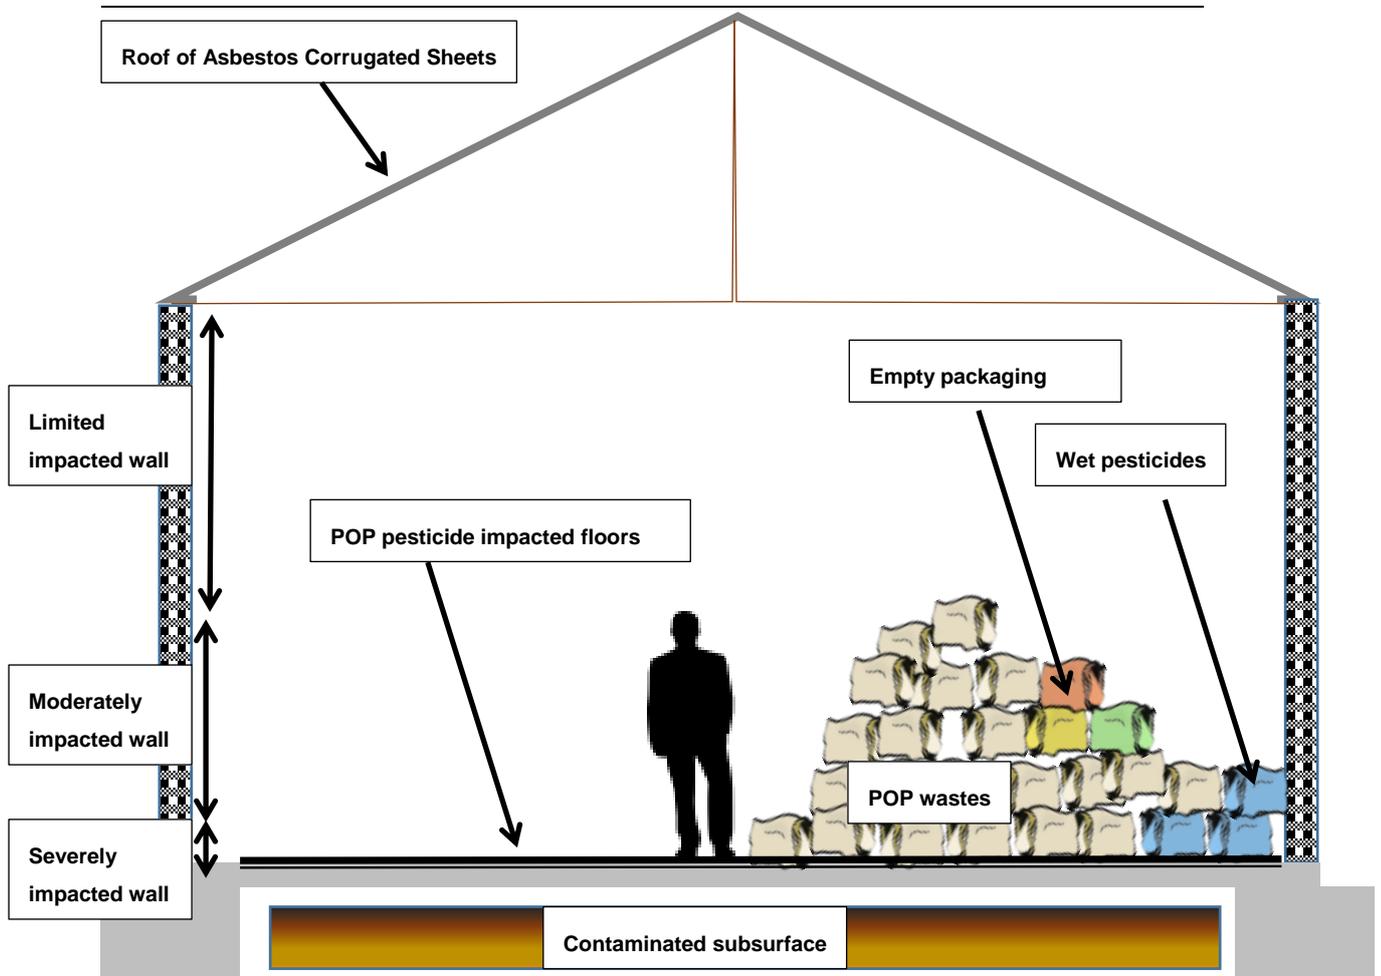
Figure 9.2 Schematic cross-section of warehouses
